Manhole Inspection Summary

Manhole # S31G__015MH

Insp Date: **11/12/08 9:58 AM**

Location Address: **front of university of md hospital**

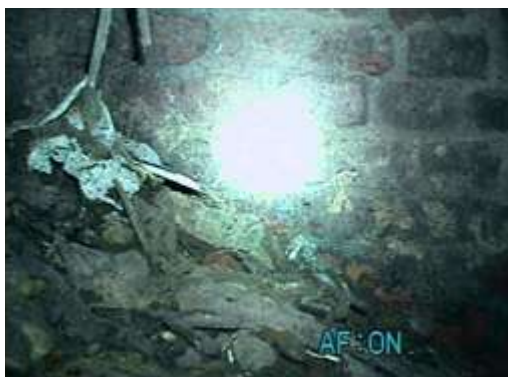
Defect 5

Condition: ☐ Sound ☐ Cracked ☐ Root Intrusion ☐ Deteriorated ☐ Leaks ☒ **Debris**

bench debris

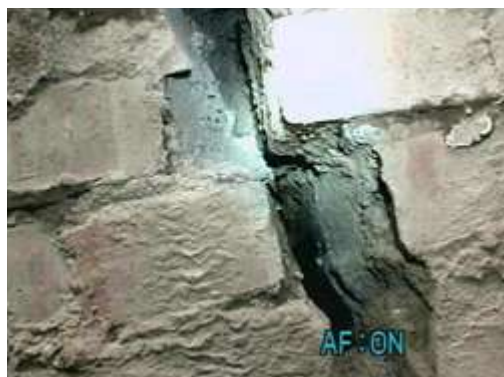
Defect 4

Condition: ☐ Sound ☒ **Cracked** ☐ Root Intrusion ☐ Loose Brick ☐ Deteriorated

fractured corbel

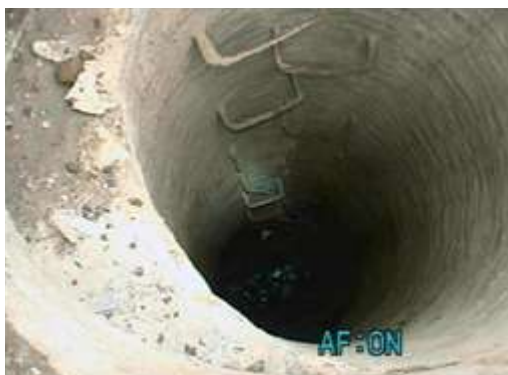
Defect 3

Count: **15** Missing: **4** ☒ **Corroded**

cor. steps

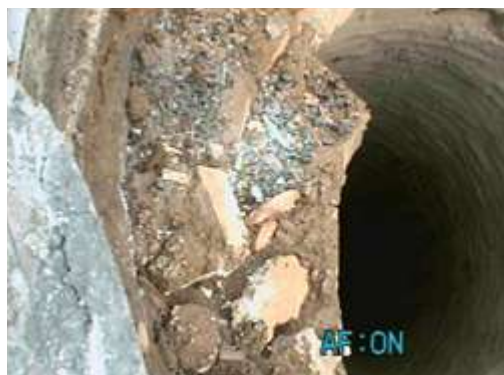
Defect 2

Offset: **10** (in.)

offset

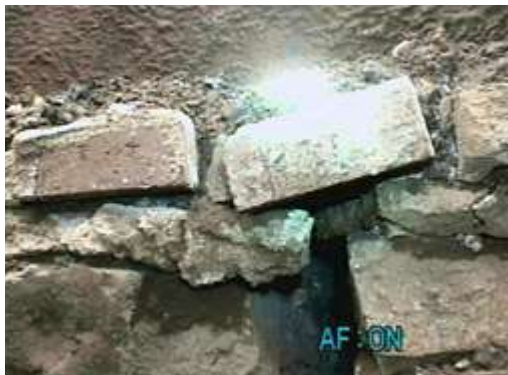
Defect 1

Condition: ☐ Sound ☒ **Cracked** ☐ Root Intrusion ☒ **Loose Brick** ☒ **Deteriorated**

chimney cracked, deteriorated, frame adj
